# State of Utah DEPARTMENT OF NATURAL RESOURCES Division of Oil, Gas & Mining

# Inspection Report Minerals Regulatory Program Date:

Mine Name: Topaz Mine	Permit Number: M/023/0003		
Pperator Name: Materion Natural Resources Company Inspection Date: April 12, 2			
Inspector(s): Wayne Western	Time: 10:30 – 11:00 am		
Other Participants: Rob Dolton - Materion	Mine Status: ACT		
Weather Condition: 40's and rain	Last Inspection: July 13, 2012  Bond Amount: \$1,398,000.00		
Bond Renewal Date: December 1, 2012			
Surface Ownership: Fee	Mineral Ownership: Fee/SITLA		
Last Year of Production: 2012	Acreage: 271

The purpose of the inspection was to document the reclamation activity at the Fluro Phase 1 backfill surface area.

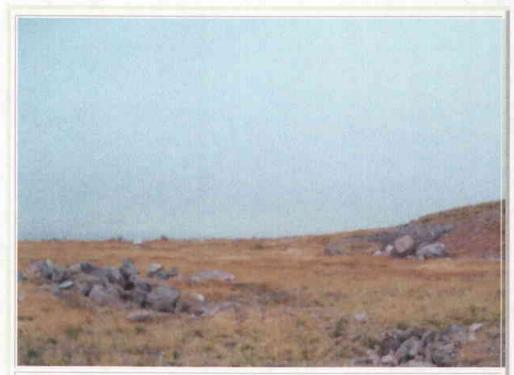
Over view of area looking south

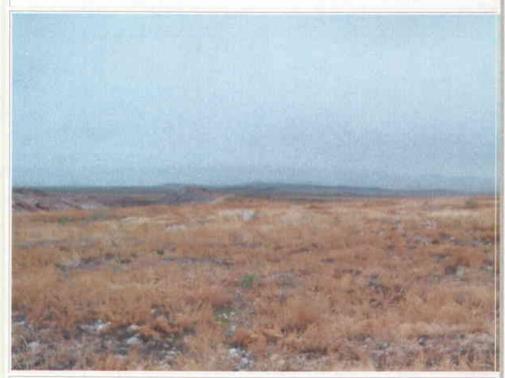
Overview of area looking west

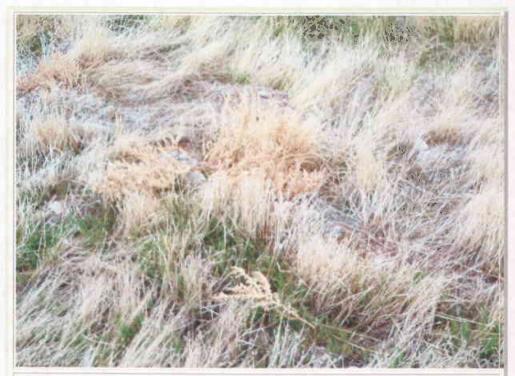
Close up of area

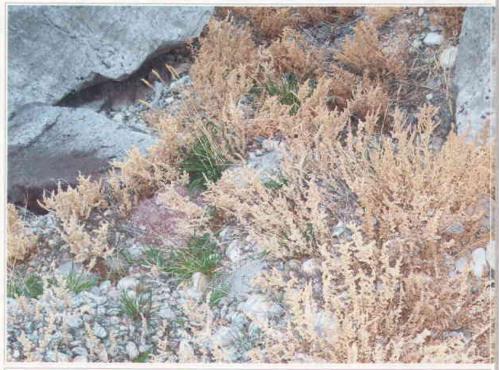
Close up of area near rock pile
